Bear Creek Diversion: Lessons Learned

By Nick Scribner (WGFD Fish Passage Coordinator)

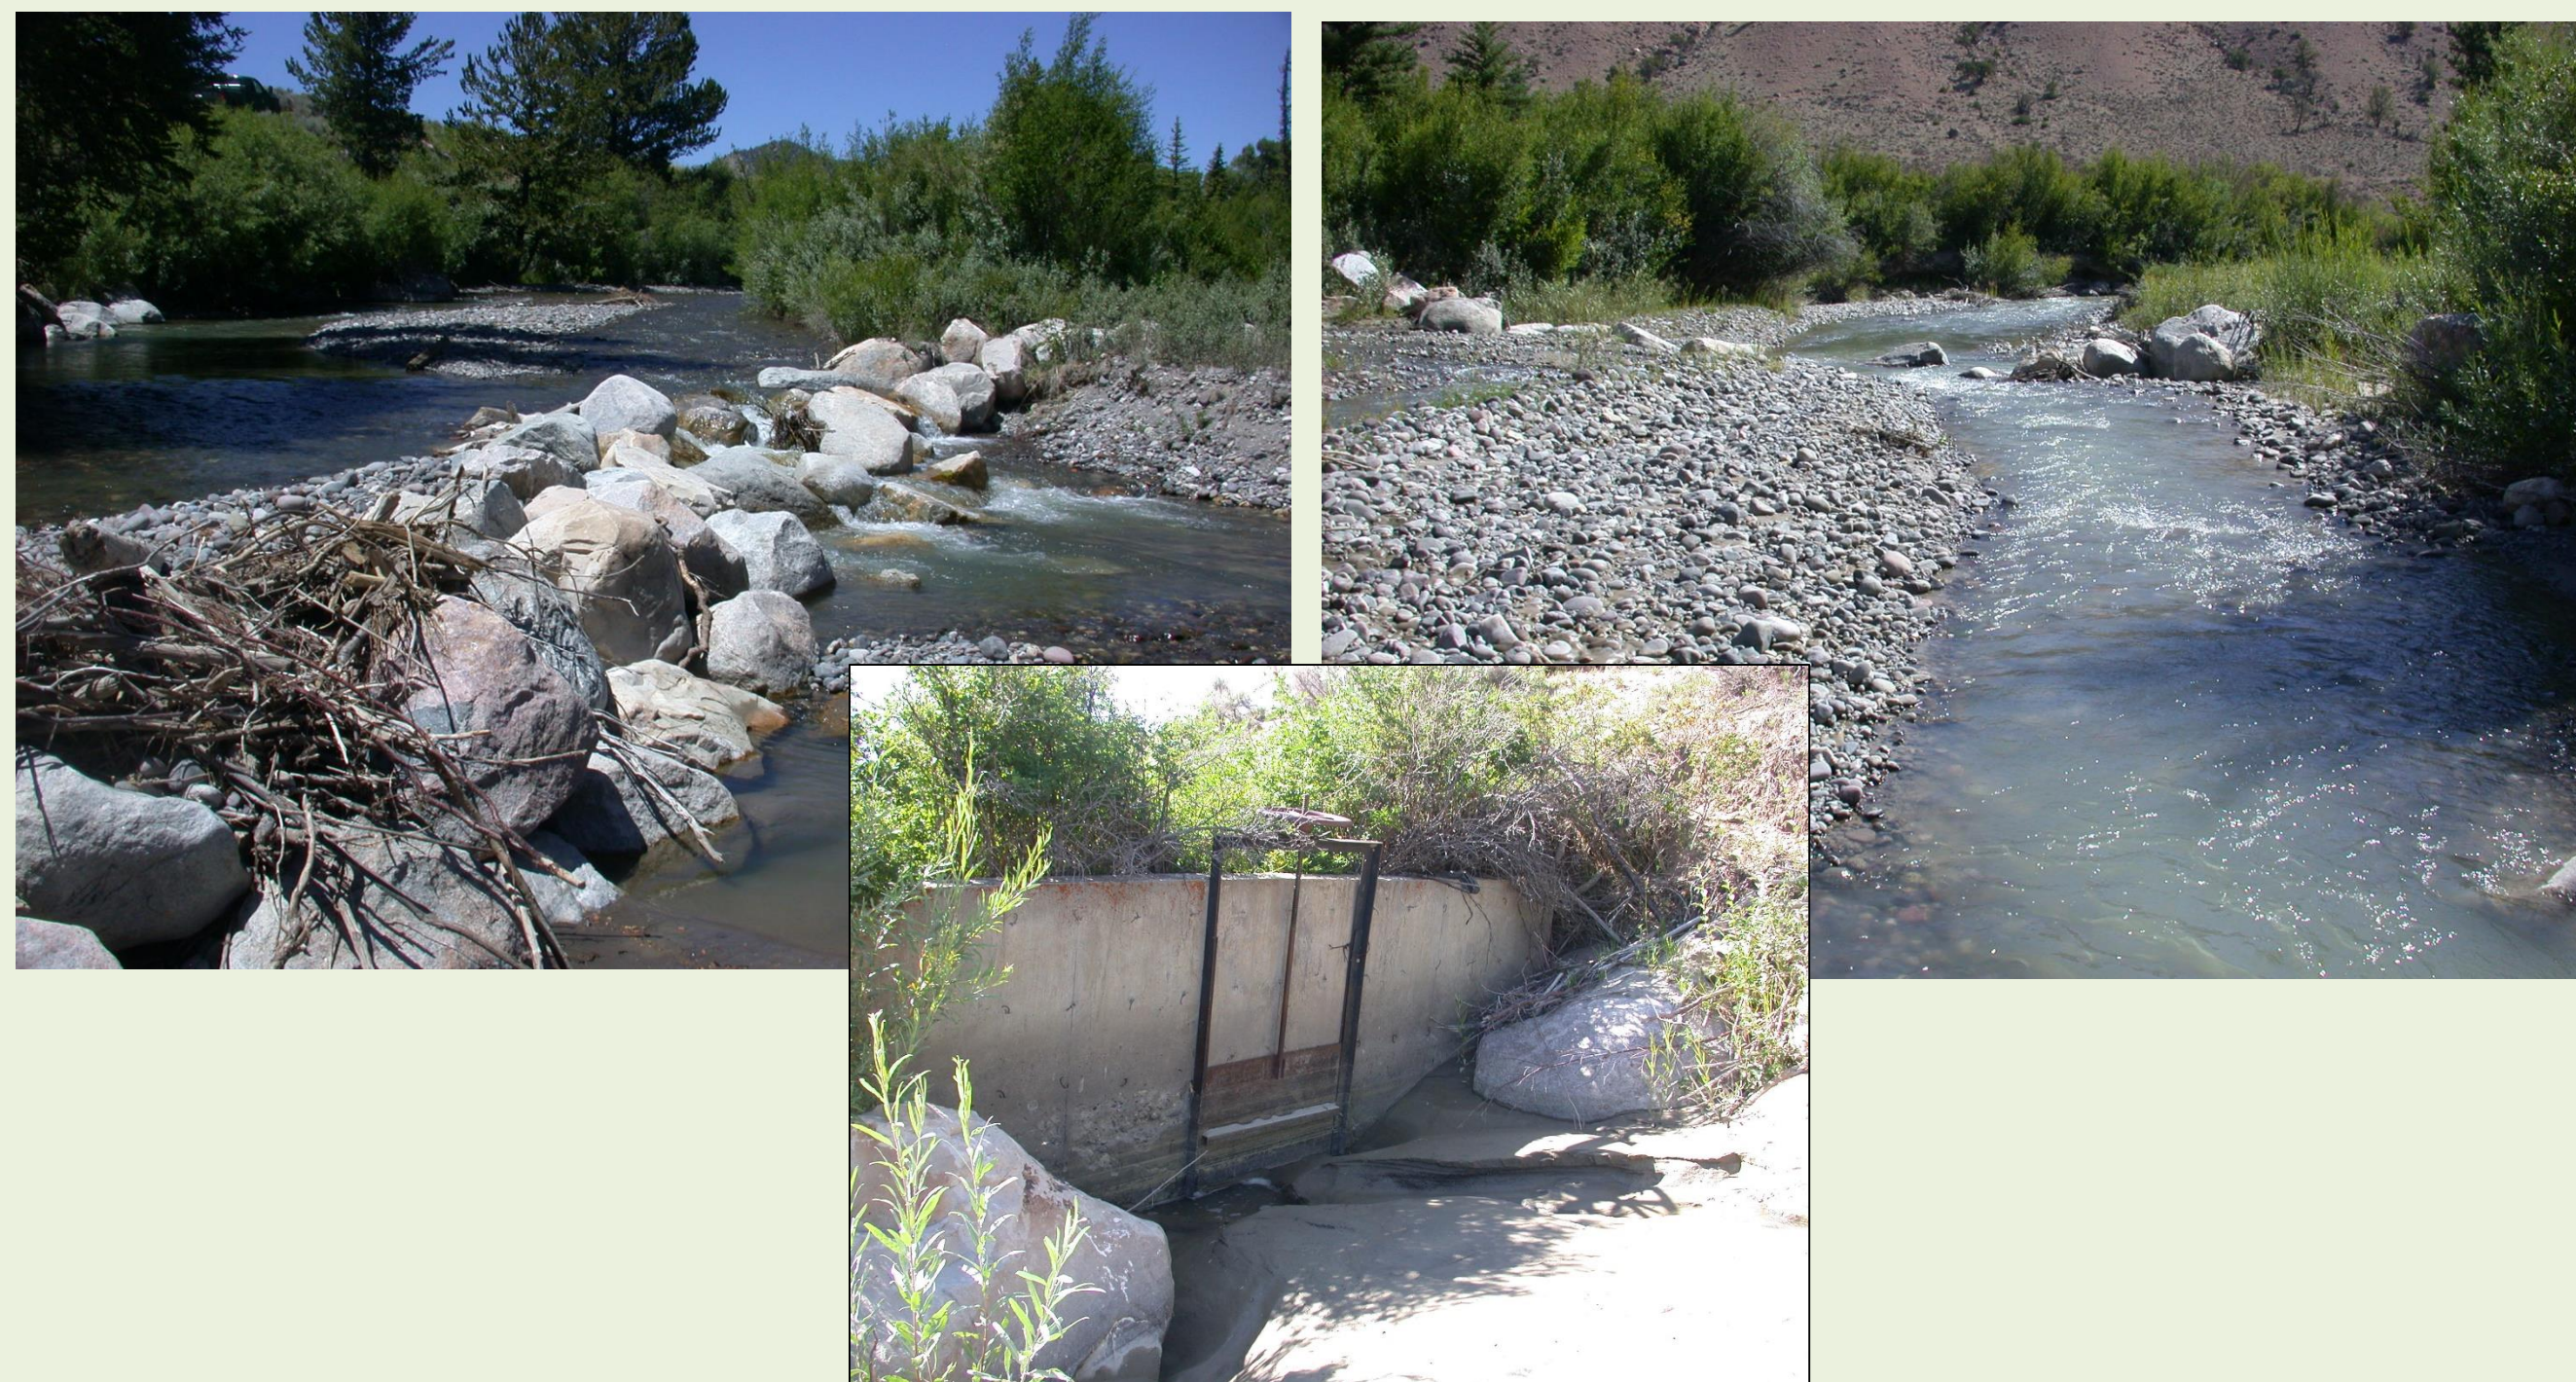
Figure 2. 2010 conditions of Bear Creek Diversion; 1 large push-up dam tied into the headgate while another smaller push-up dam spanned the channel downstream. Notice the leaning headwall and sediment aggradation at headgate. The diversion required annual maintenance to divert water.

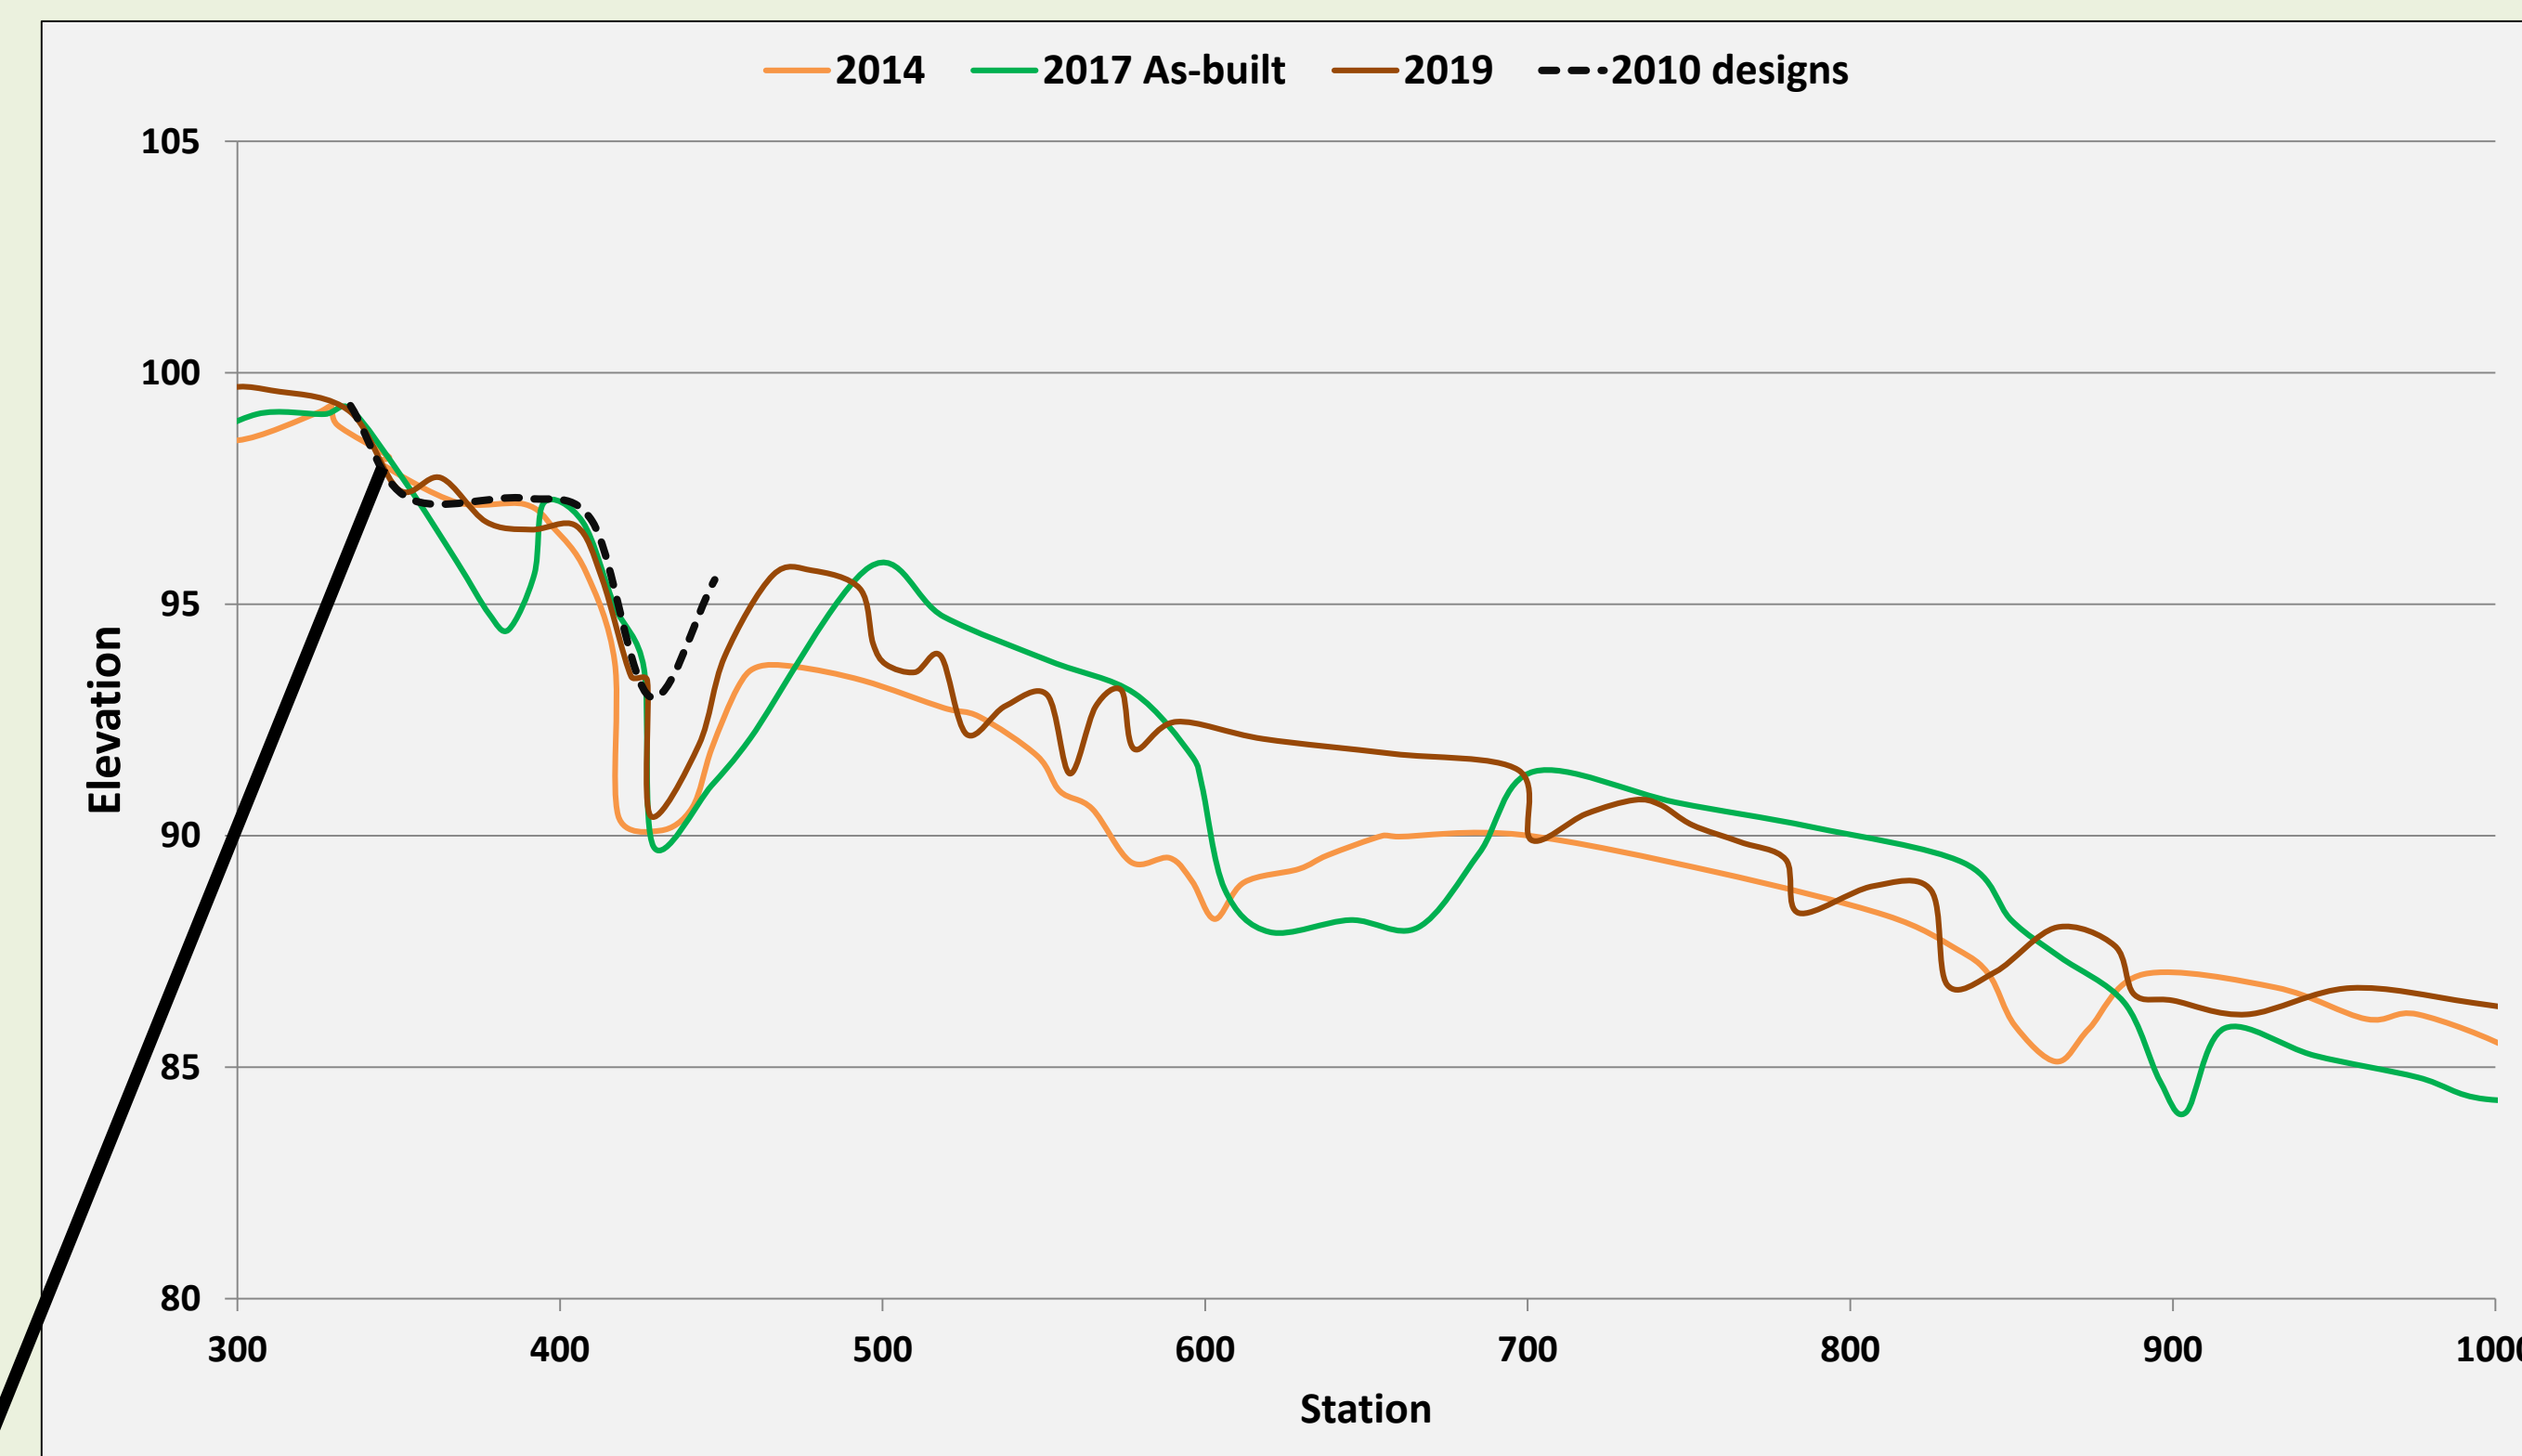
Figure 5. Longitudinal profile data of the Bear Creek Diversion reach. The Black dashed line corresponds to the 2010 design elevations. 2014 data were collected after the meander cutoff downstream and 2017 data is of as-built conditions of the constructed riffles. 2019 data represents current conditions.

In 2014, high spring runoff cutoff a meander downstream (Fig. 4) of the diversion causing water surface levels to drop nearly 2 ft on the lower rock vane at base flows from 2012 post-construction conditions (Fig. 5). This impacted fish passage as several large YSC were seen having difficulty navigating past the lower rock vane. Survey data were collected in 2014 for use in designs to stabilize the channel and return the water surface level to 2012 conditions. In 2017, two constructed riffles (Fig. 6) were built to raise the channel bed and water surface levels to improve fish passage and reduce the risk of further damage of the lower rock vane (Fig. 7). Repairs made in 2017 have adjusted slightly but appear to have stabilized the channel and maintain connectivity past this diversion.

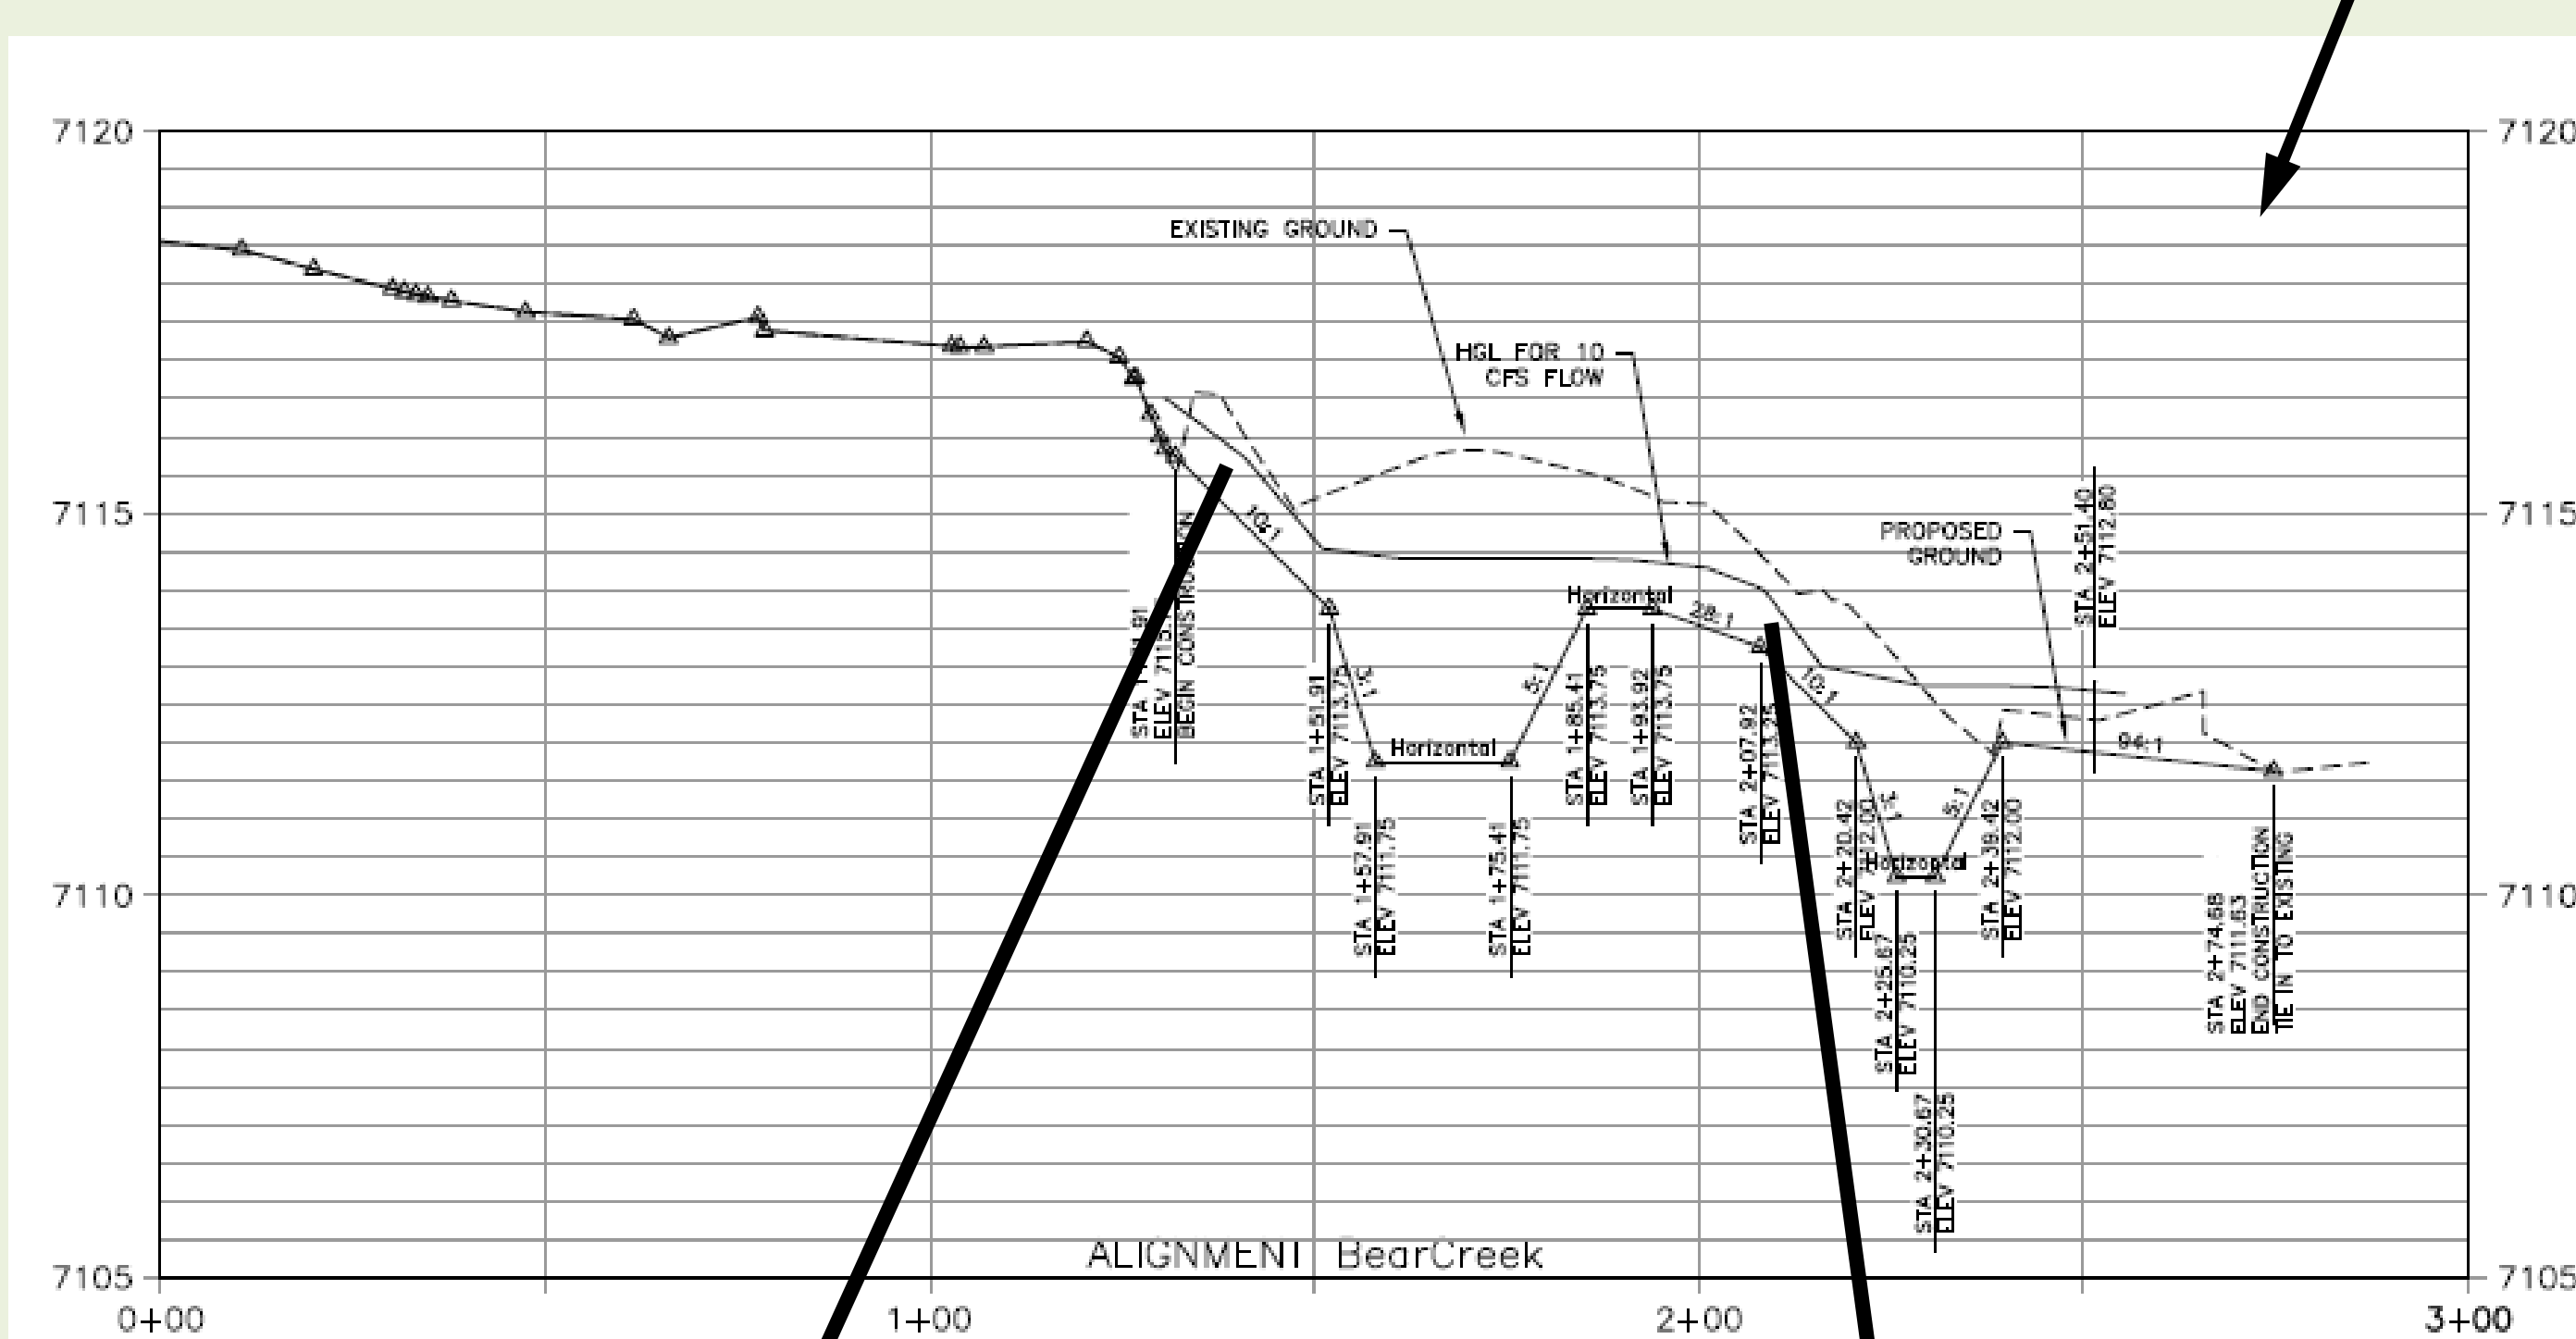
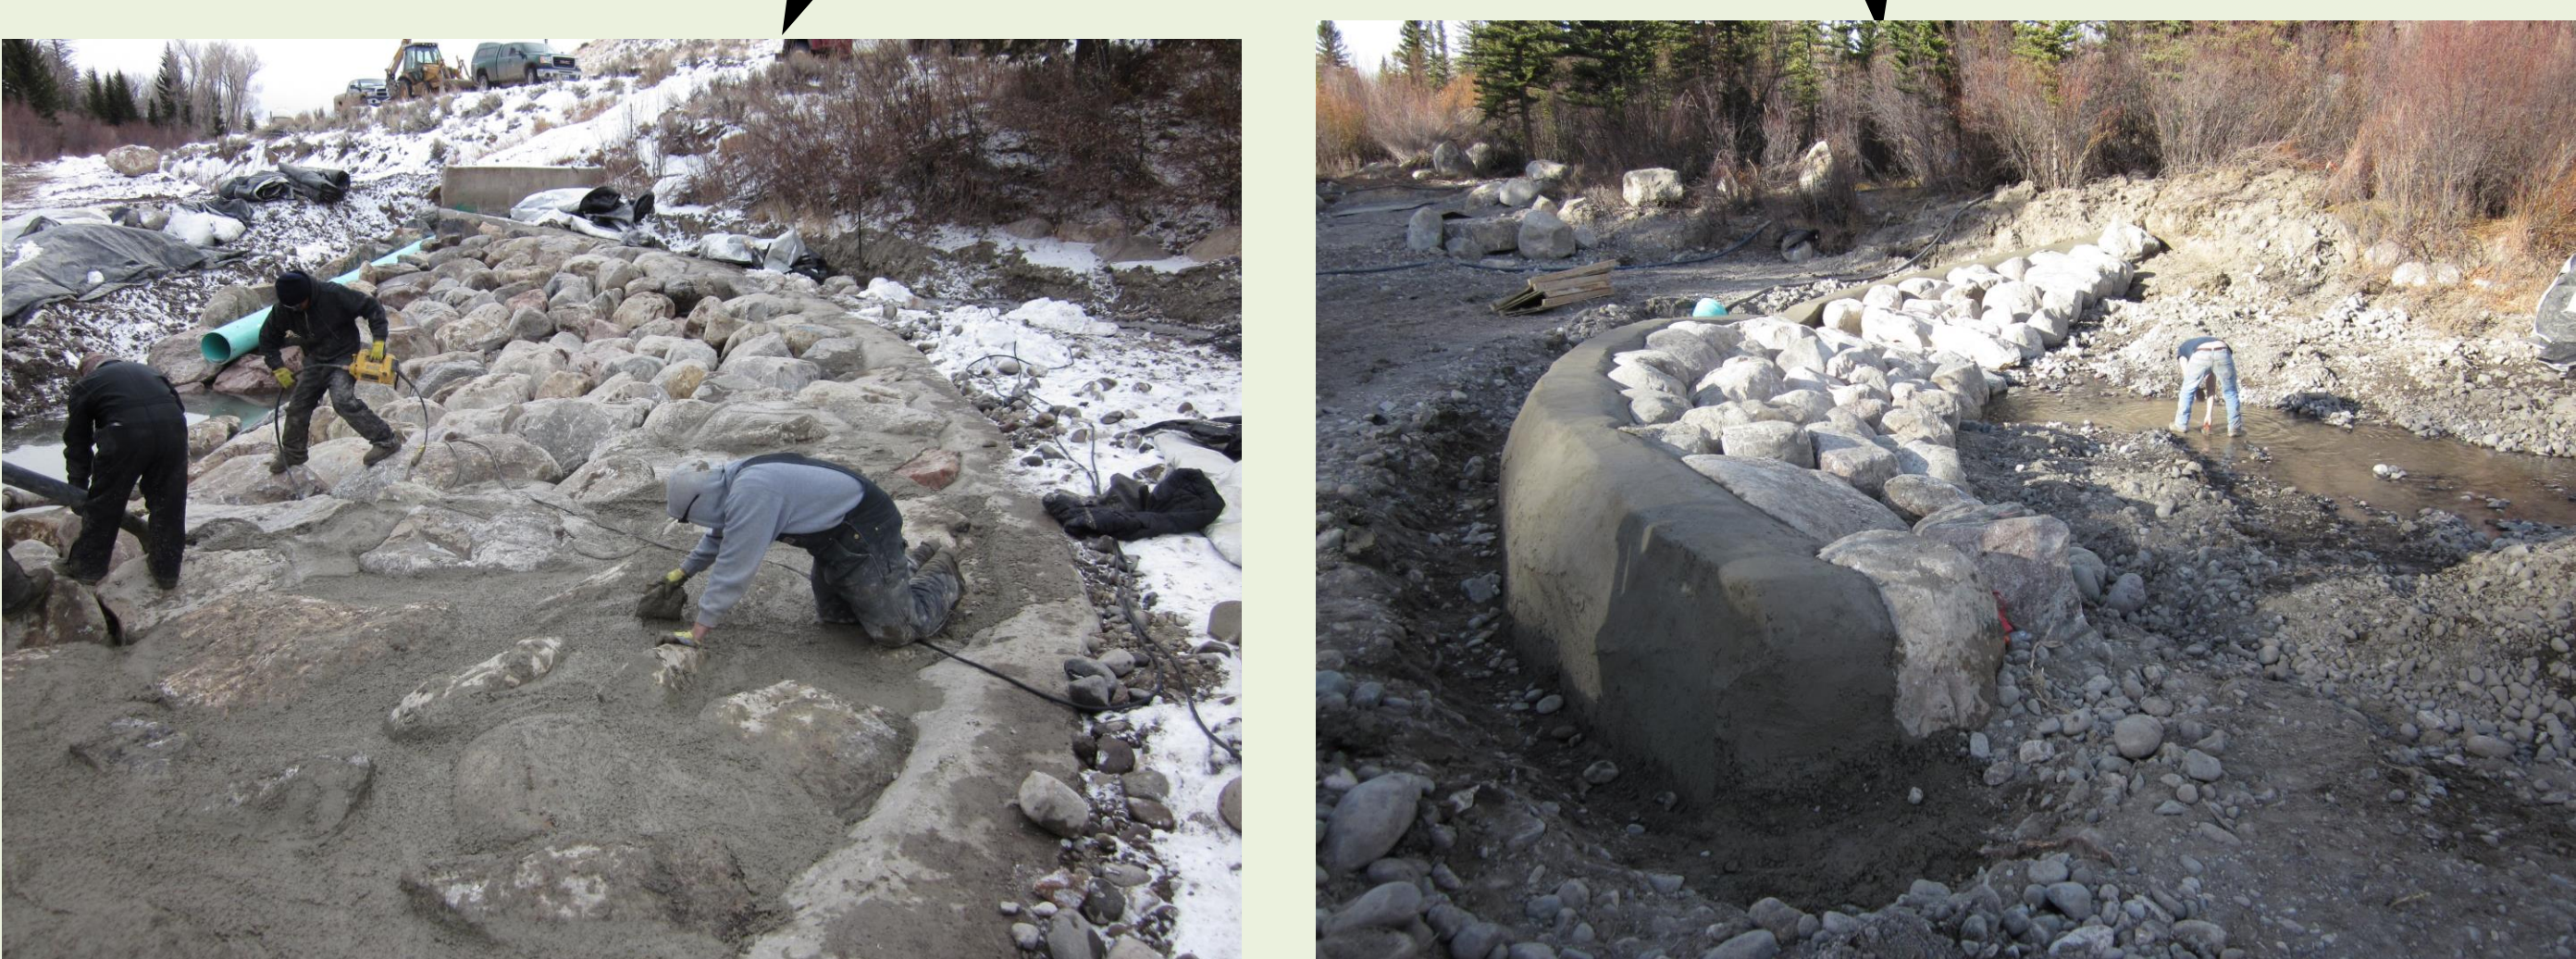
Upper grouted vane looking towards headgate. Teal pipe is the sluiceway

Lower grouted vane after pouring the concrete cut-off wall upstream

Figure 3. Engineer's plans for the grouted rock vanes that were built in 2010. Arrows correspond with the location of the vanes in the drawings and what they looked like during construction.

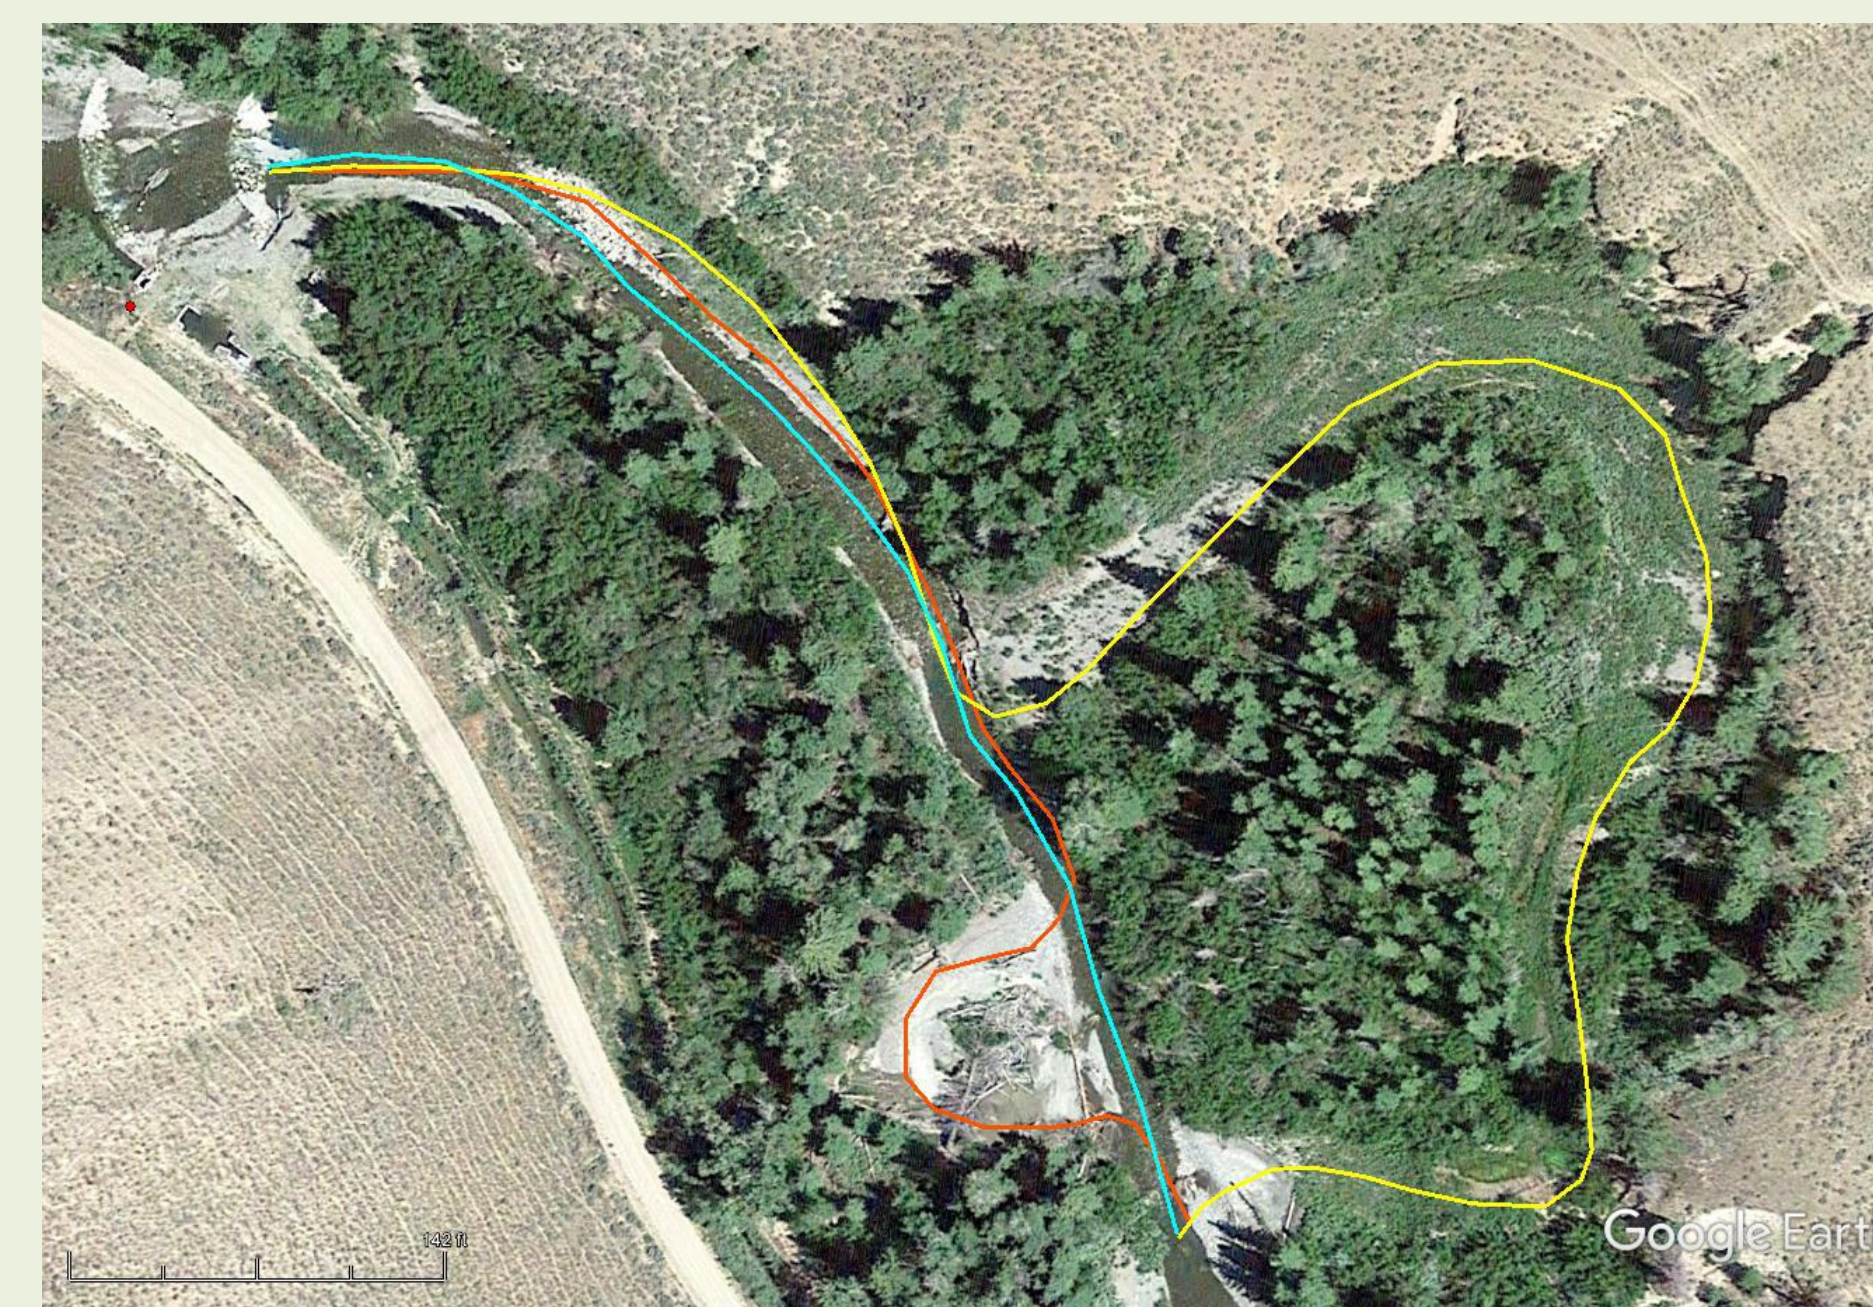
Figure 4. 2014 aerial photo: Yellow = 1994 channel (1565'), Orange = 2009 channel (908'), and Blue = 2014 channel (761'). Meander cutoffs since 1994 reduced the channel distance by 51%. The diversion stopped this headcut from moving upstream.

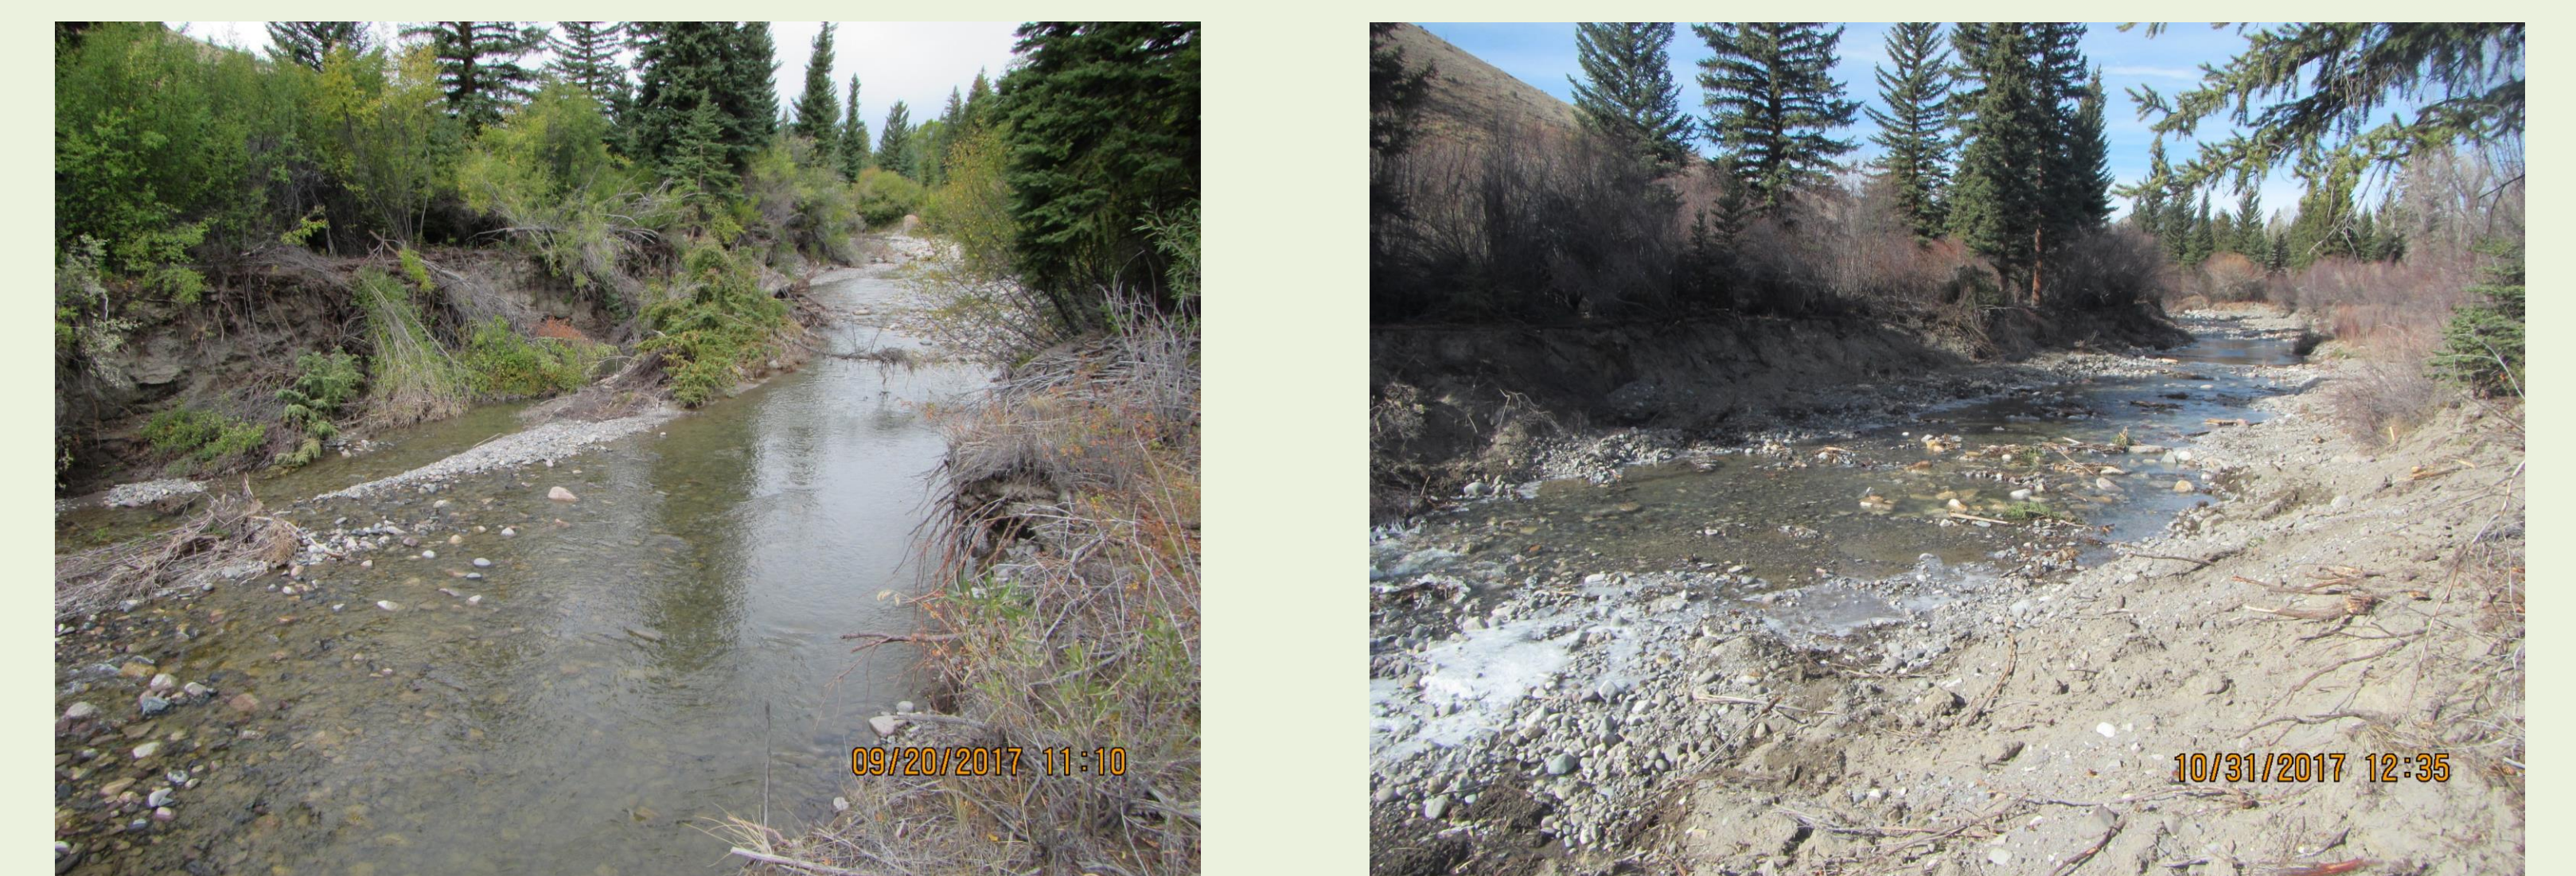
Figure 6. Before (left) and after (right) 2017 constructed riffle installation looking upstream.

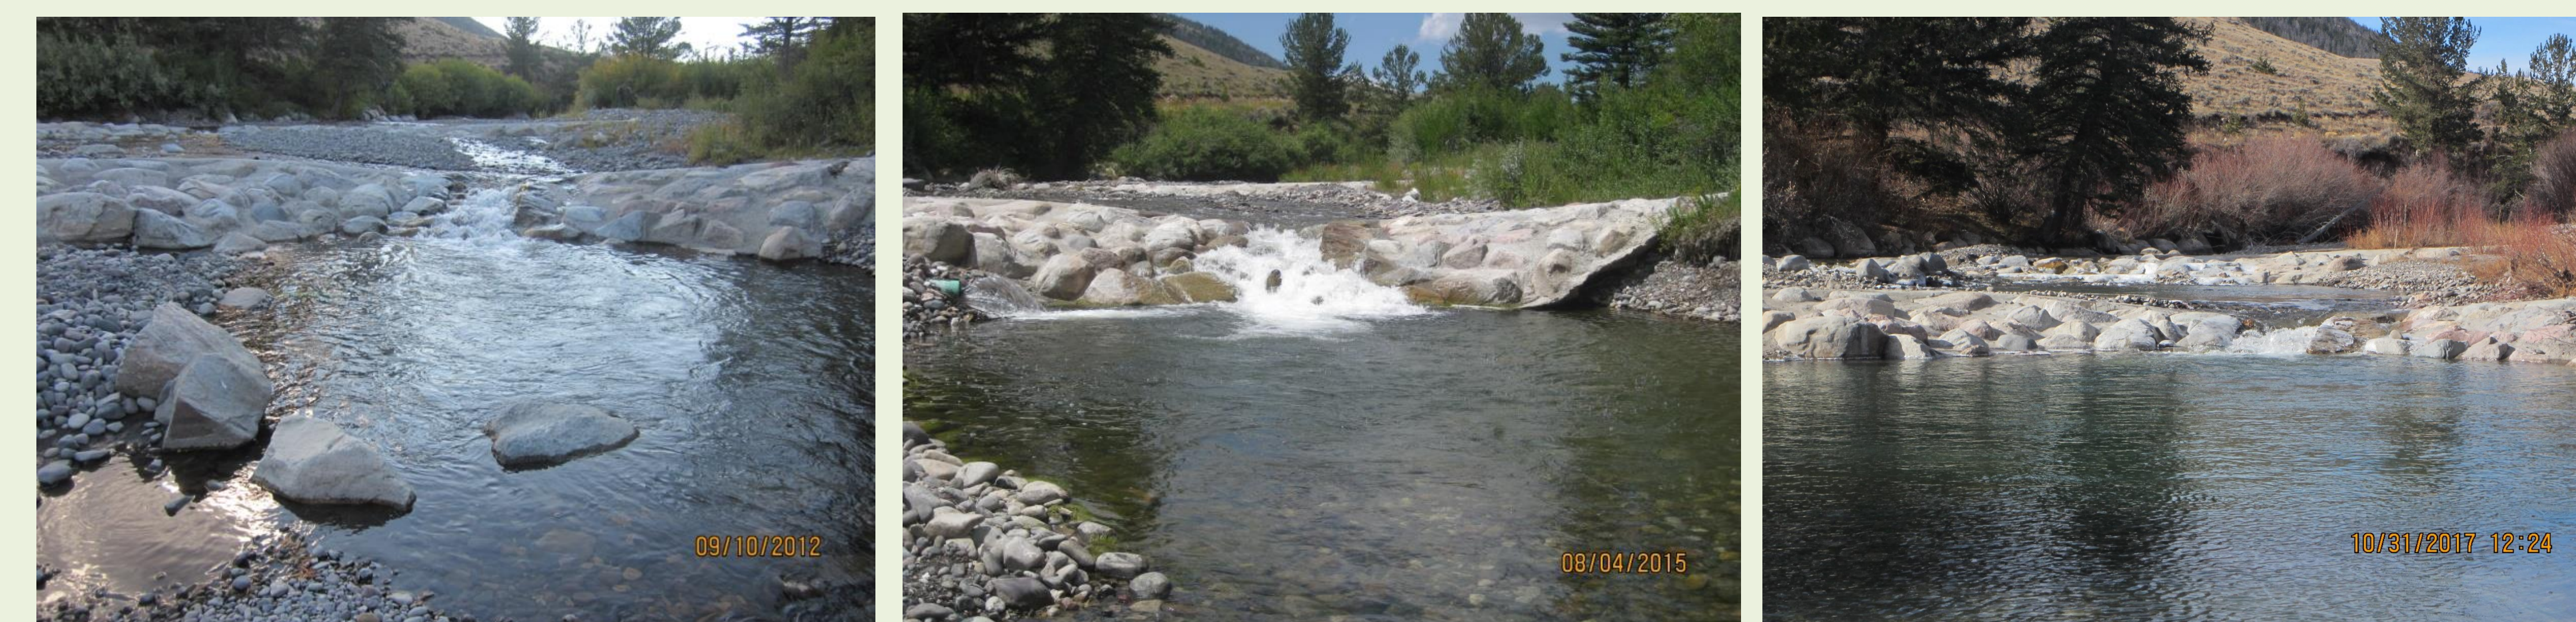
Figure 7. Water surface conditions below lower rock vane in 2012, 2015, and after channel reconstruction in 2017.
