Stream habitat conditions in the North River before and after restoration activities.

Presentation by Brandon Fair and Stuart Robertson
Center For Aquatic Technology Transfer
Presenting Authors: Colin Krause, Andy Dolloff, Dawn Kirk,
Craig Roghair

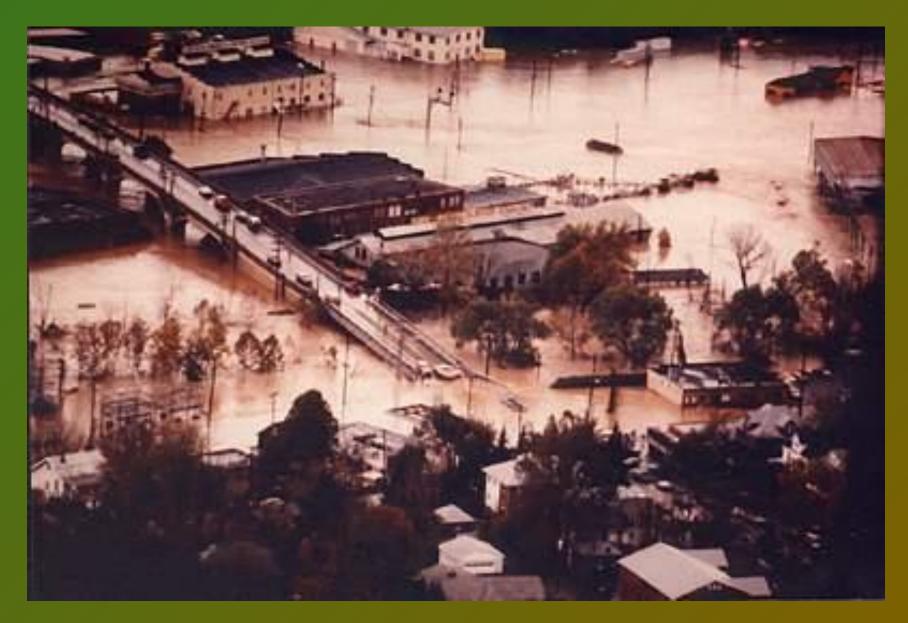
November 1985 Hurricane Juan

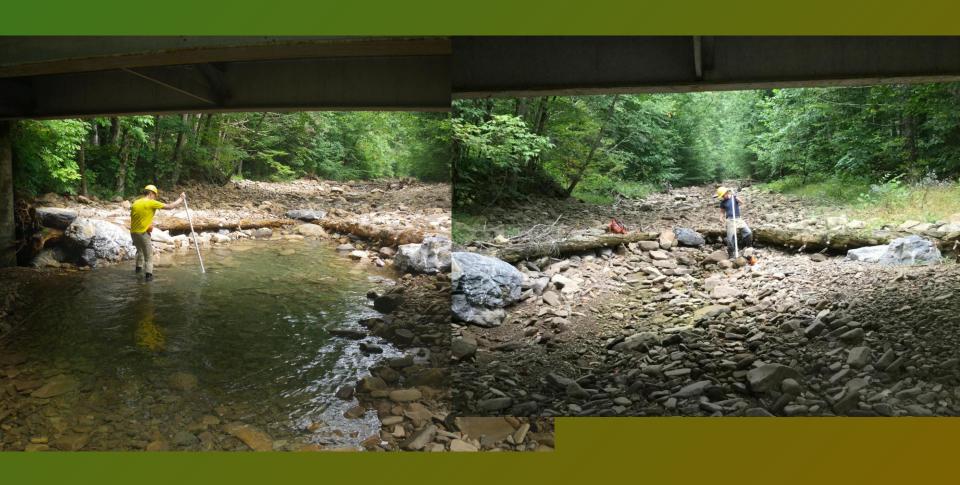
Section E, 2,385m Restoration Structure 2014 vs 2019

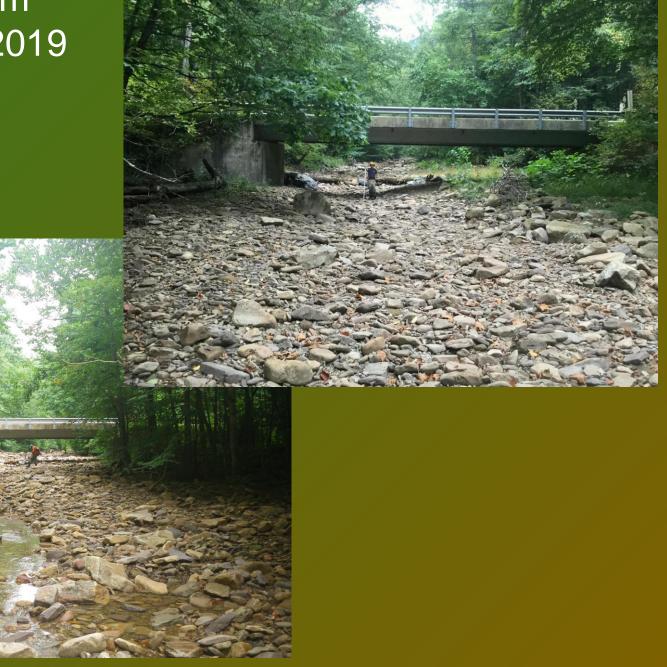
Section E, 2,379m Bridge 2014 vs 2019

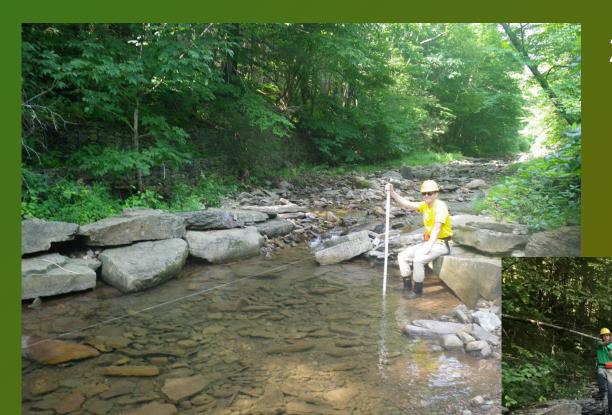
Section E, 4,582m Restoration Structure

2014 vs 2019

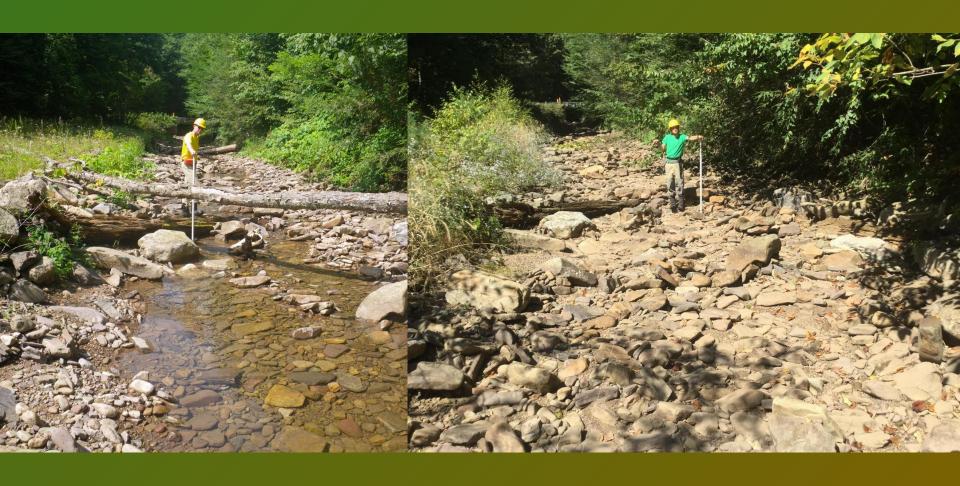
Section E, 4,443m Restoration Structure 2014 vs 2019

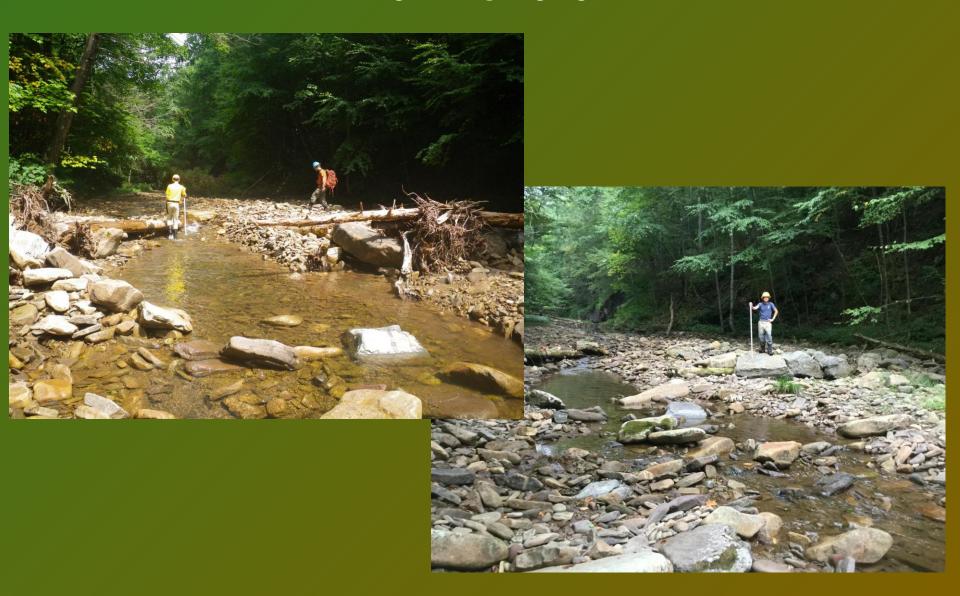
Section E, 2630m Restoration Structure 2014 vs 2019
